INDIAN FACTORY

Service Shots

FOR
Indian Dealers

TIMING MAGNETO EQUIPPED SPORT SCOUT

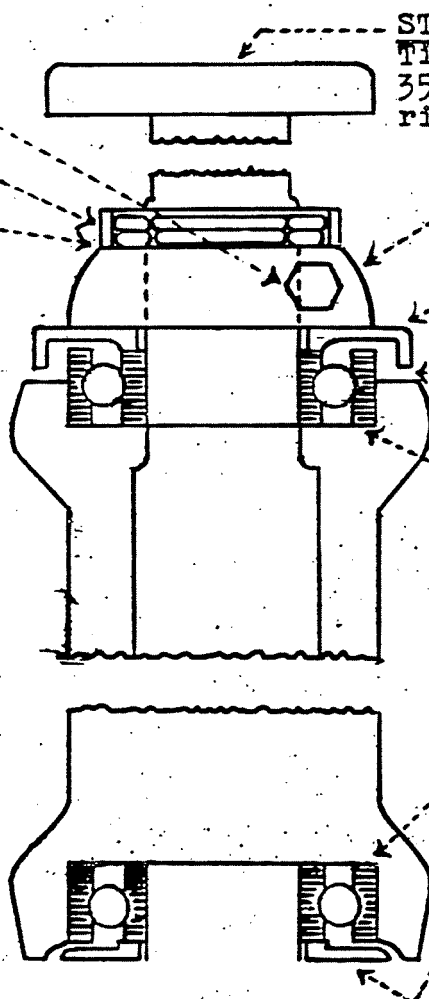
1. A loose steering head bearing adjustment will affect the handling of the machine at speeds above 35 MPH. The front end will be unstable and difficult to control on rough roads and on turns. It will have a tendency to weave.
2. A tight steering head bearing adjustment will affect the handling of the machine at low speeds. It will be difficult to ride the machine in a straight line. It will have a tendency to sway. There also is danger of the ball bearings pitting the bearing cone and race when it is adjusted too tight.

STEERING DAMPER WHEEL
Tighten when riding above 35 MPH. Loosen when riding below 35.

FORK STEM BRACKET
Clean paint and dirt from upper and lower surfaces at assembly.

LOWER BEARING WASHER
Assemble with the shoulder facing up, flat surface down.

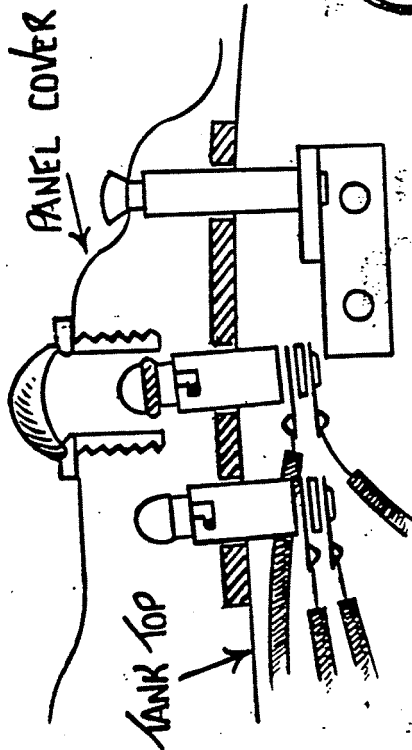
248 MODEL INSTRUMENT LIGHT SOCKET CONVERSION TO OVERCOME BULB FAILURES

To prevent burning out the light bulbs in the 125 c.c. Chek motorcycles, an inductive reactance (electromagnet or choke coil) may be placed in the light circuit.

REASSEMBLE WITH TWO NEW SOCKETS, PAD, WIRE AND RING. USE EXISTING HARNESS WIRE AND SWITCH WIRES

WIRE TO BLUE SPOT ON SWITCH 8" LONG

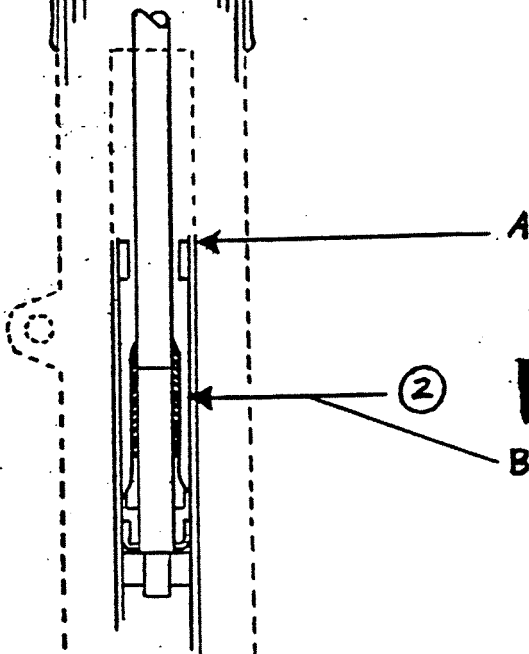
CONVERTING FORK PLUNGER

FRONT FORK IMPROVEMENTS ON 149-249 MODELS

Saw off plunger tube flush with upper bushing.

Slide sleeve over plunger rod and push down against upper stop. Then braze or solder in place.
