INDIAN FACTORY

Service Shots

FOR
Indian Dealers

TIMING MAGNETO EQUIPPED SPORT SCOUT

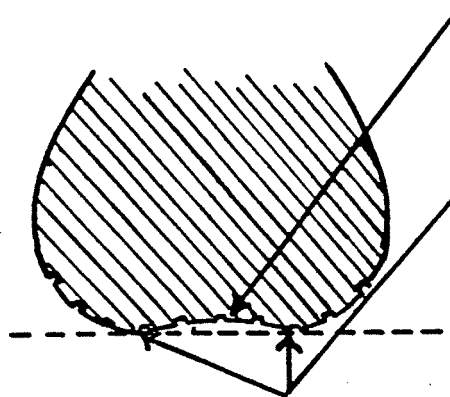
1. Tread Wear with Tire Under-Inflated
5.00 x 16 tires
that are ridden
with 12 to 14 lbs.
air pressure will
take this shape.

Low air pressures
will cause the
front end to weave
on turns.

The center rib will be pushed up from the weight of the machine and rider. This rib will not wear as fast as the others. The two ribs on either side of the center rib will wear rapidly because of the side motion or wiping action as they enter and leave the road surface.

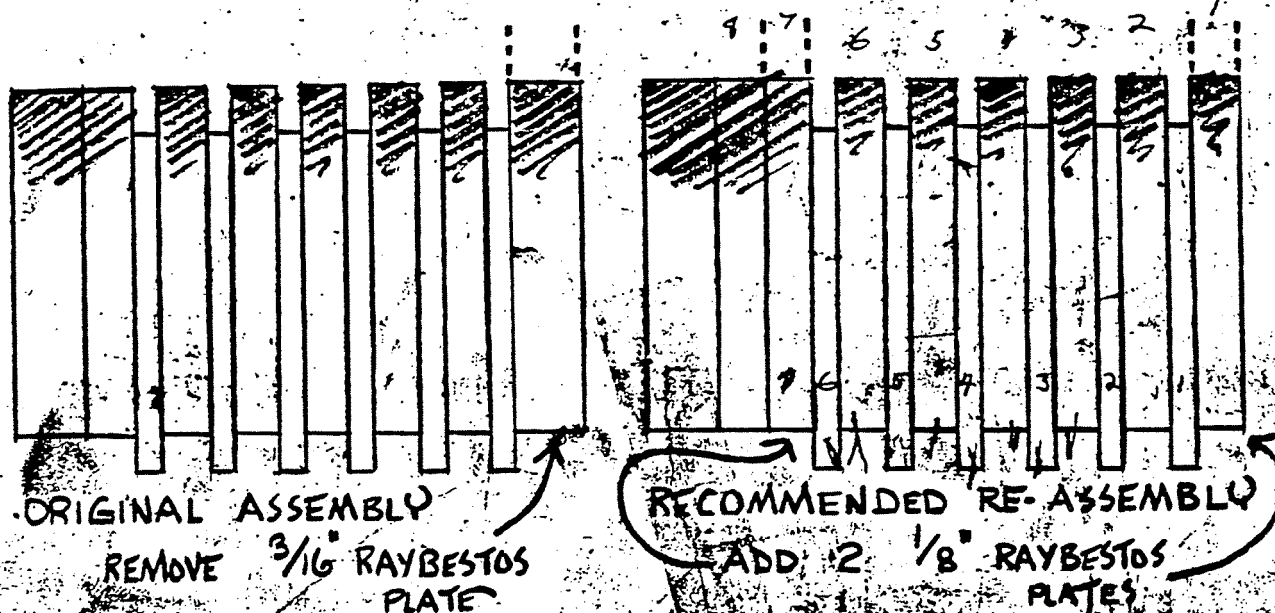
TO OVERCOME SLIPPAGE AND CHATTER OR GROAN IN 346-347 MODEL CLUTCHES

The illustrations show the original assembly and the recommended use.

NOTE: Remove sludge and glaze from surface of Raybestos plates with wire brush before they are assembled.

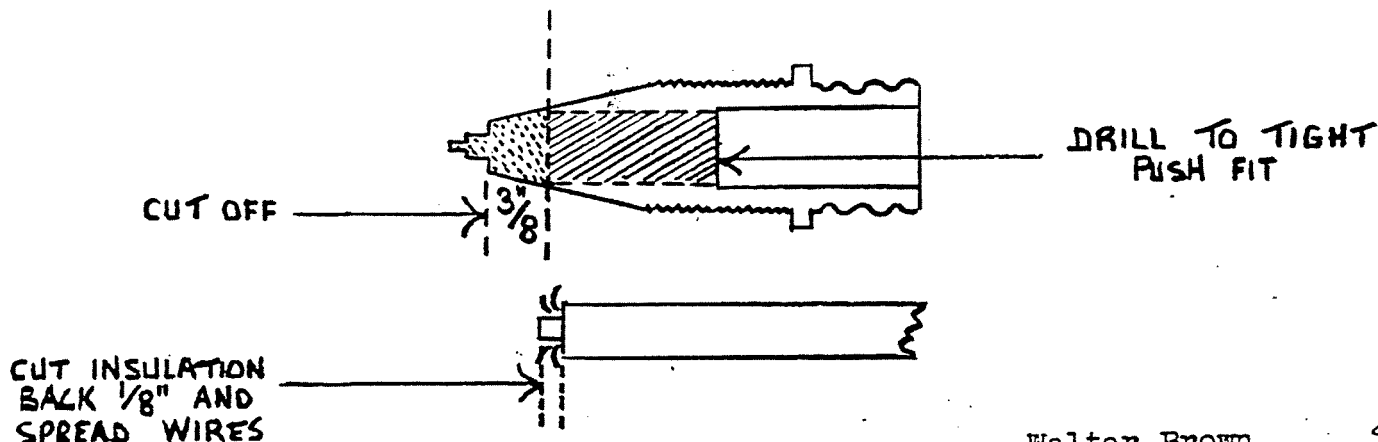
The spark plug wire forms the insulation rather than the contact holder and, in most cases, you will find that the engine will start readily and no further spark plug fouling will be experienced.

It will be necessary to cut and spread the spark plug wire as shown also. Assemble the holder nut, holder casing and rubber ring on the high tension wire. Push the wire through the contact holder, screw the contact holder in the crankcase, push wire into place firmly, push the rubber ring and holder collar down, and tighten the holder nut.

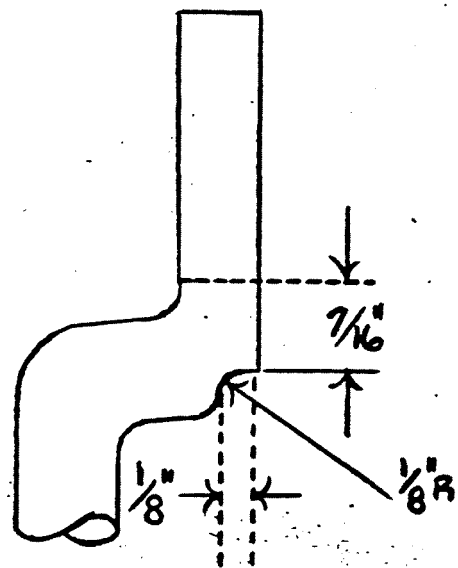
The compactness of the Indian 74, Standard Scout and 101 model transmissions makes it difficult to get a good hold on the clutch sprocket nut when tightening, even when using the Special Wrench No. 27-T-350 for this nut.

A more firm grip on this nut can be obtained by relieving Wrench No. 27-T-350 at the heel, as shown in the illustration below.

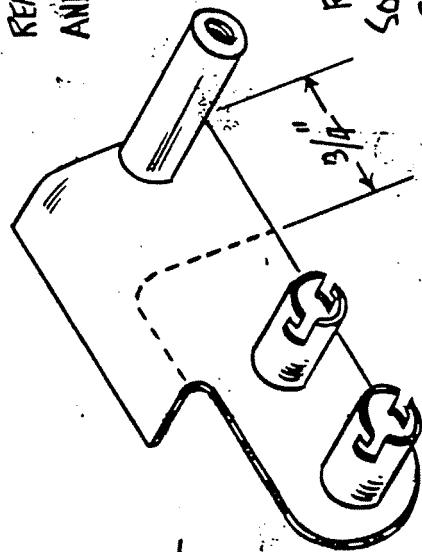
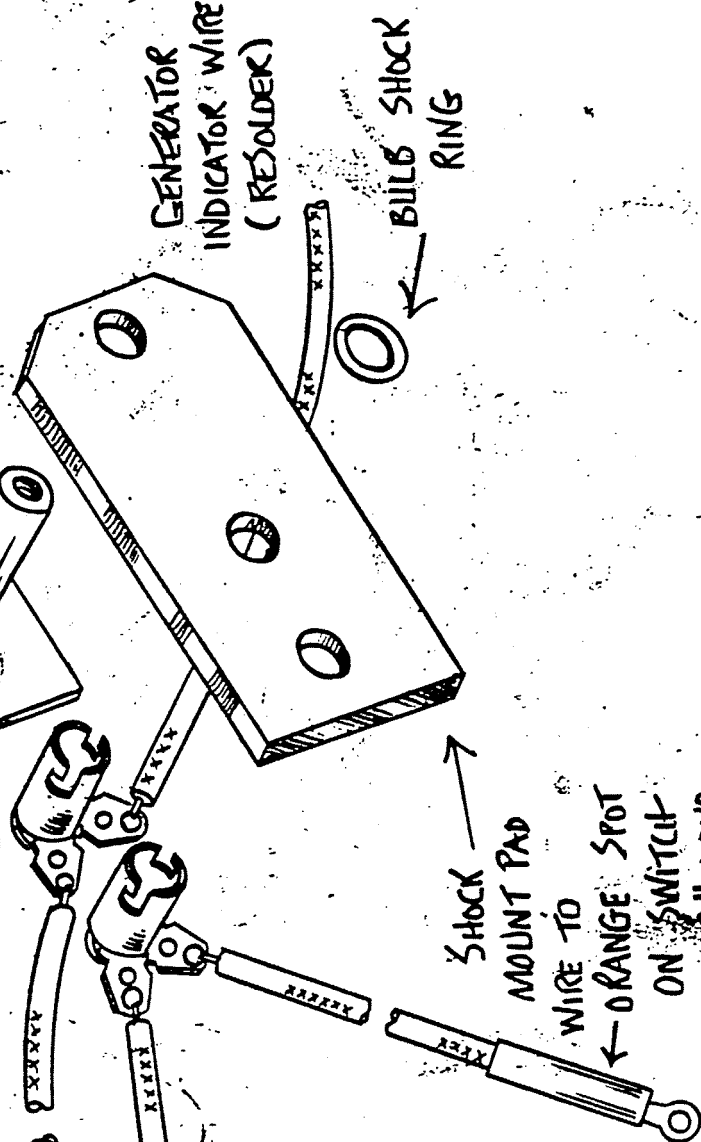
248 MODEL INSTRUMENT LIGHT SOCKET CONVERSION TO OVERCOME BULB FAILURES

To prevent burning out the light bulbs in the 125 c.c. Chek motorcycles, an inductive reactance (electromagnet or choke coil) may be placed in the light circuit.

REASSEMBLE WITH TWO NEW SOCKETS, PAD, WIRE AND RING. USE EXISTING HARNESS WIRE AND SWITCH WIRES

WIRE TO BLUE SPOT ON SWITCH 8" LONG

1. Remove instrument panel cover.
2. Remove left gas tank.
3. Remove instrument and light panel bracket.
4. Unsolder the wires on the bulb sockets.
5. Solder one wire 7" long and one wire 8" long on new socket, as shown in sketch. (SPEEDOMETER LIGHT)
6. Solder new wire 8" long and generator indicator light wire from harness on other new socket, as shown in sketch.
7. Cut instrument and light panel bracket, as shown in sketch, and reassemble on frame. Replace gas tank.
8. Insert both bulb sockets half way through rubber pad. Assemble pad over panel stud and adjust pad to lie flat on top of gas tank. Connect wires on switch as shown.

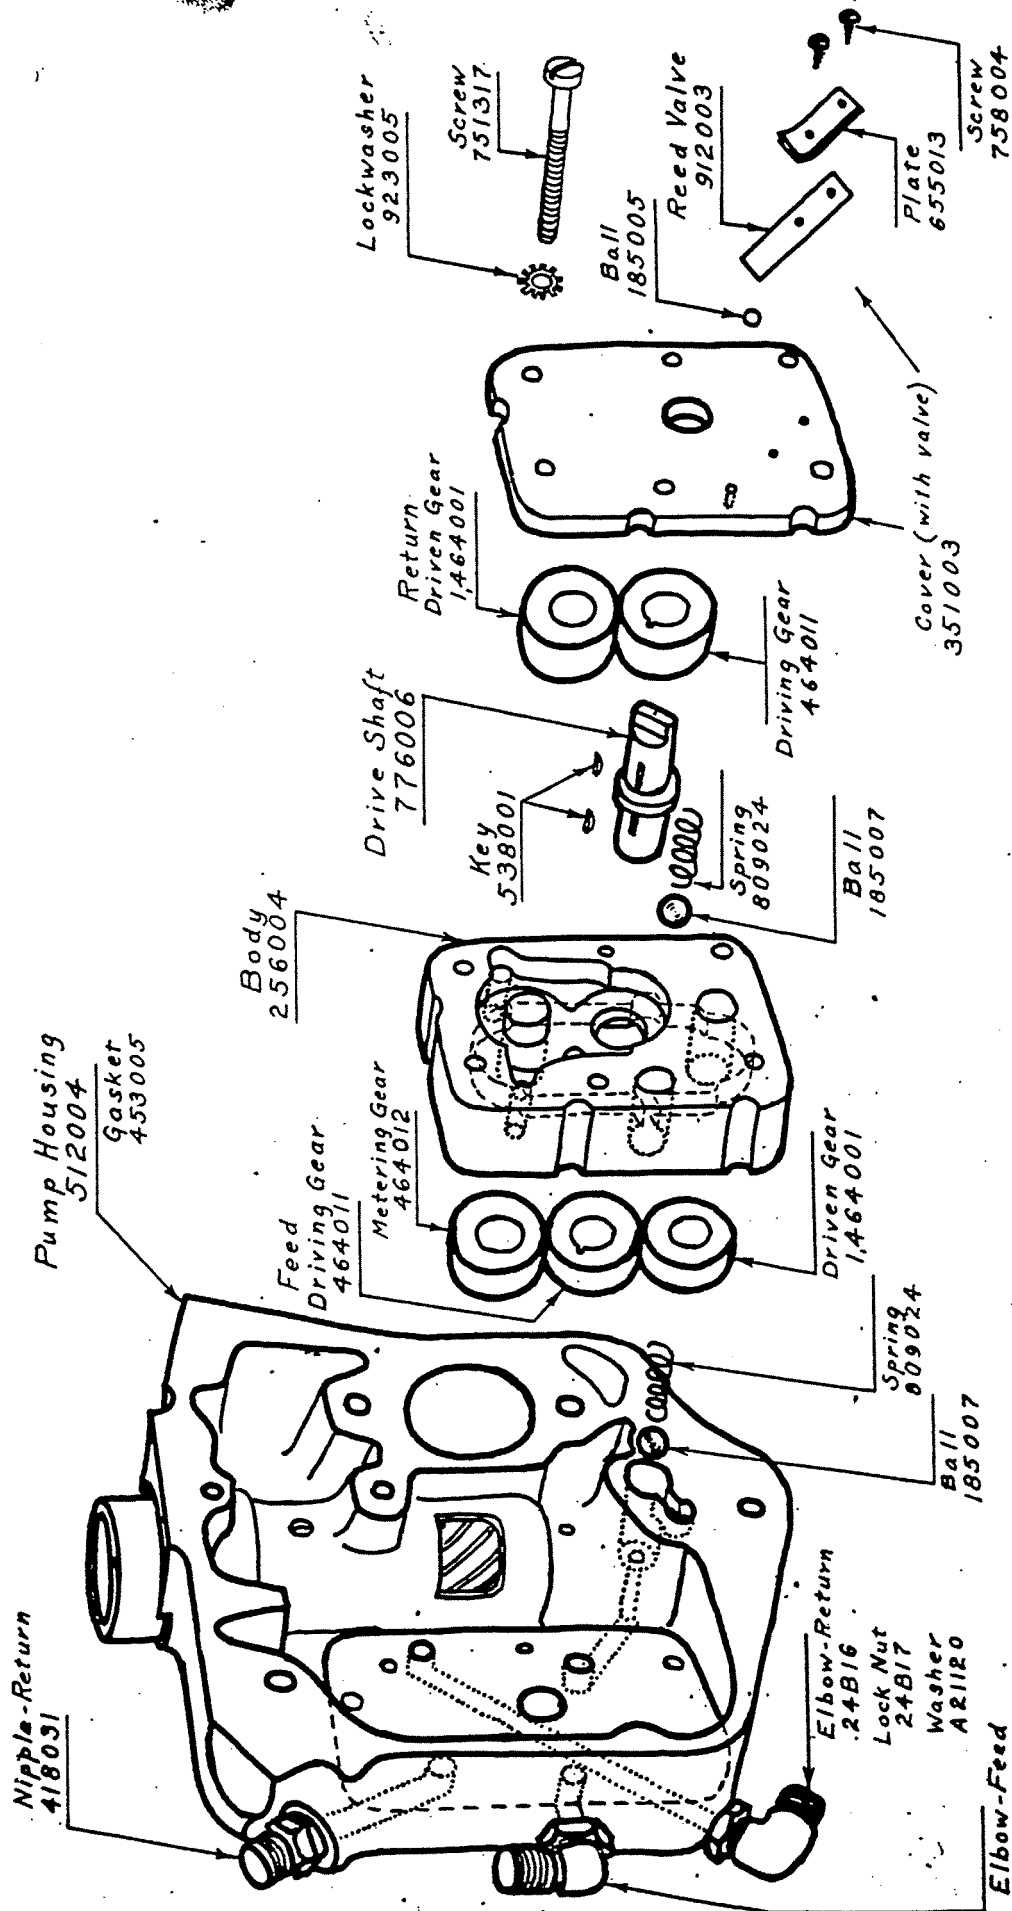
348 OIL PUMP ASSEMBLY

The reverse safety valve (6), a 1/8" ball and flat spring on pump body cover, must have a positive seal to prevent air leaks. The feed pump will suck air instead of drawing No. 7 ball check valve open to allow oil to flow to the gears if there is an air leak at safety valve (6)..

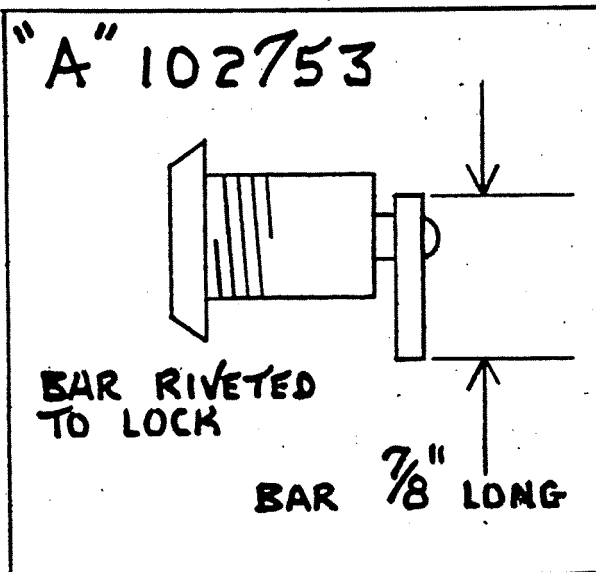
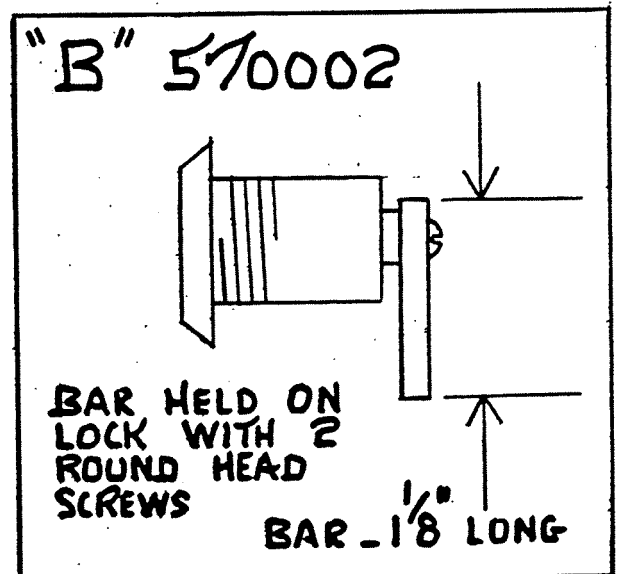
The difference is in the length of the bar. On lock number 102753, the bar is $7/8$ " long, as shown in sketch "A", and on lock number 570002, (sketch "B") the bar is $1-1/8$ " long. The methods of attaching the bars to the lock are also different, one being riveted to the locks and the other fastened to the lock with two round head screws.

When entering orders for locks, please note which type of lock is required and order according to the part number shown.

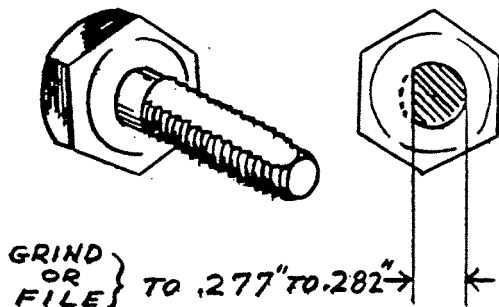
ROCKER ARM SHAFT SCREW

1. A sump plug screen that is partially or totally clogged with foreign material.
2. A sump plug that is loose or has a bad gasket surface.
3. A pinion shaft seal that has worked out of the cam case cover.
4. Rocker arm shaft screws that have too wide or deep a "flat" ground on them.

1. The sump plug may be removed and washed clean and replaced, making sure the gasket is in good condition and the surfaces on the crankcase and sump plug are flat and clean.
2. A sump plug that is loose should be removed and washed clean. The surfaces and gasket must be inspected before reassembling and tightening. Any rough area on the crankcase or sump plug must be filed smooth and the gasket replaced if not in good condition.
3. When the pinion shaft seal works out of the cam case cover, it will be necessary to press it back in place and stake or punch the aluminum around the edge of the seal to hold it firmly in place.
4. When the rocker arm shaft screws allow too much oil to flow into the rocker boxes, it will be necessary to replace them with screws that measure according to the dimensions given (.277" to .282") in Service Bulletin I-1.

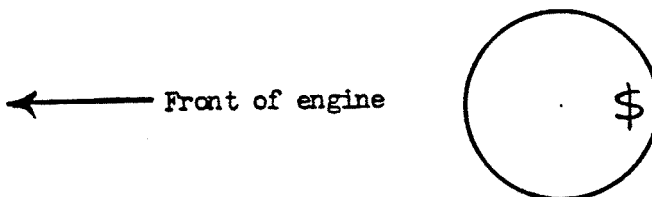
The sketch shows the proper position of the timing mark.

Be sure that the distributor points are set at $.018$ " to $.020$ " and that lever is fully advanced (in toward the engine) before moving the distributor body in the clamp to break the points. The narrow cam lobe breaks the points to fire the front cylinder.

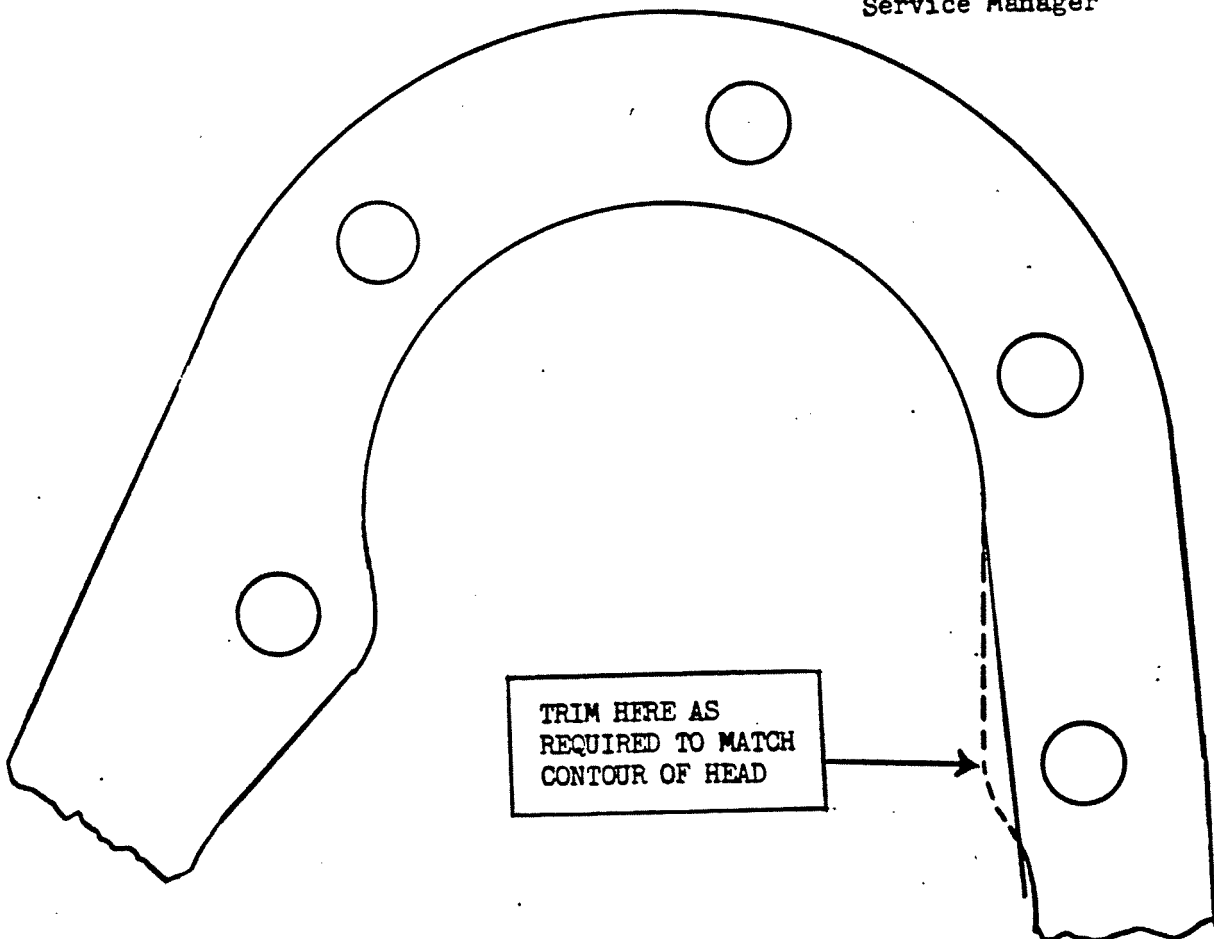
The gasket should be trimmed as shown in the sketch so that it follows the contour of the recess in the cylinder head. The gasket projecting beyond the edge of the head into the combustion chamber may cause detonation or pre-ignition.

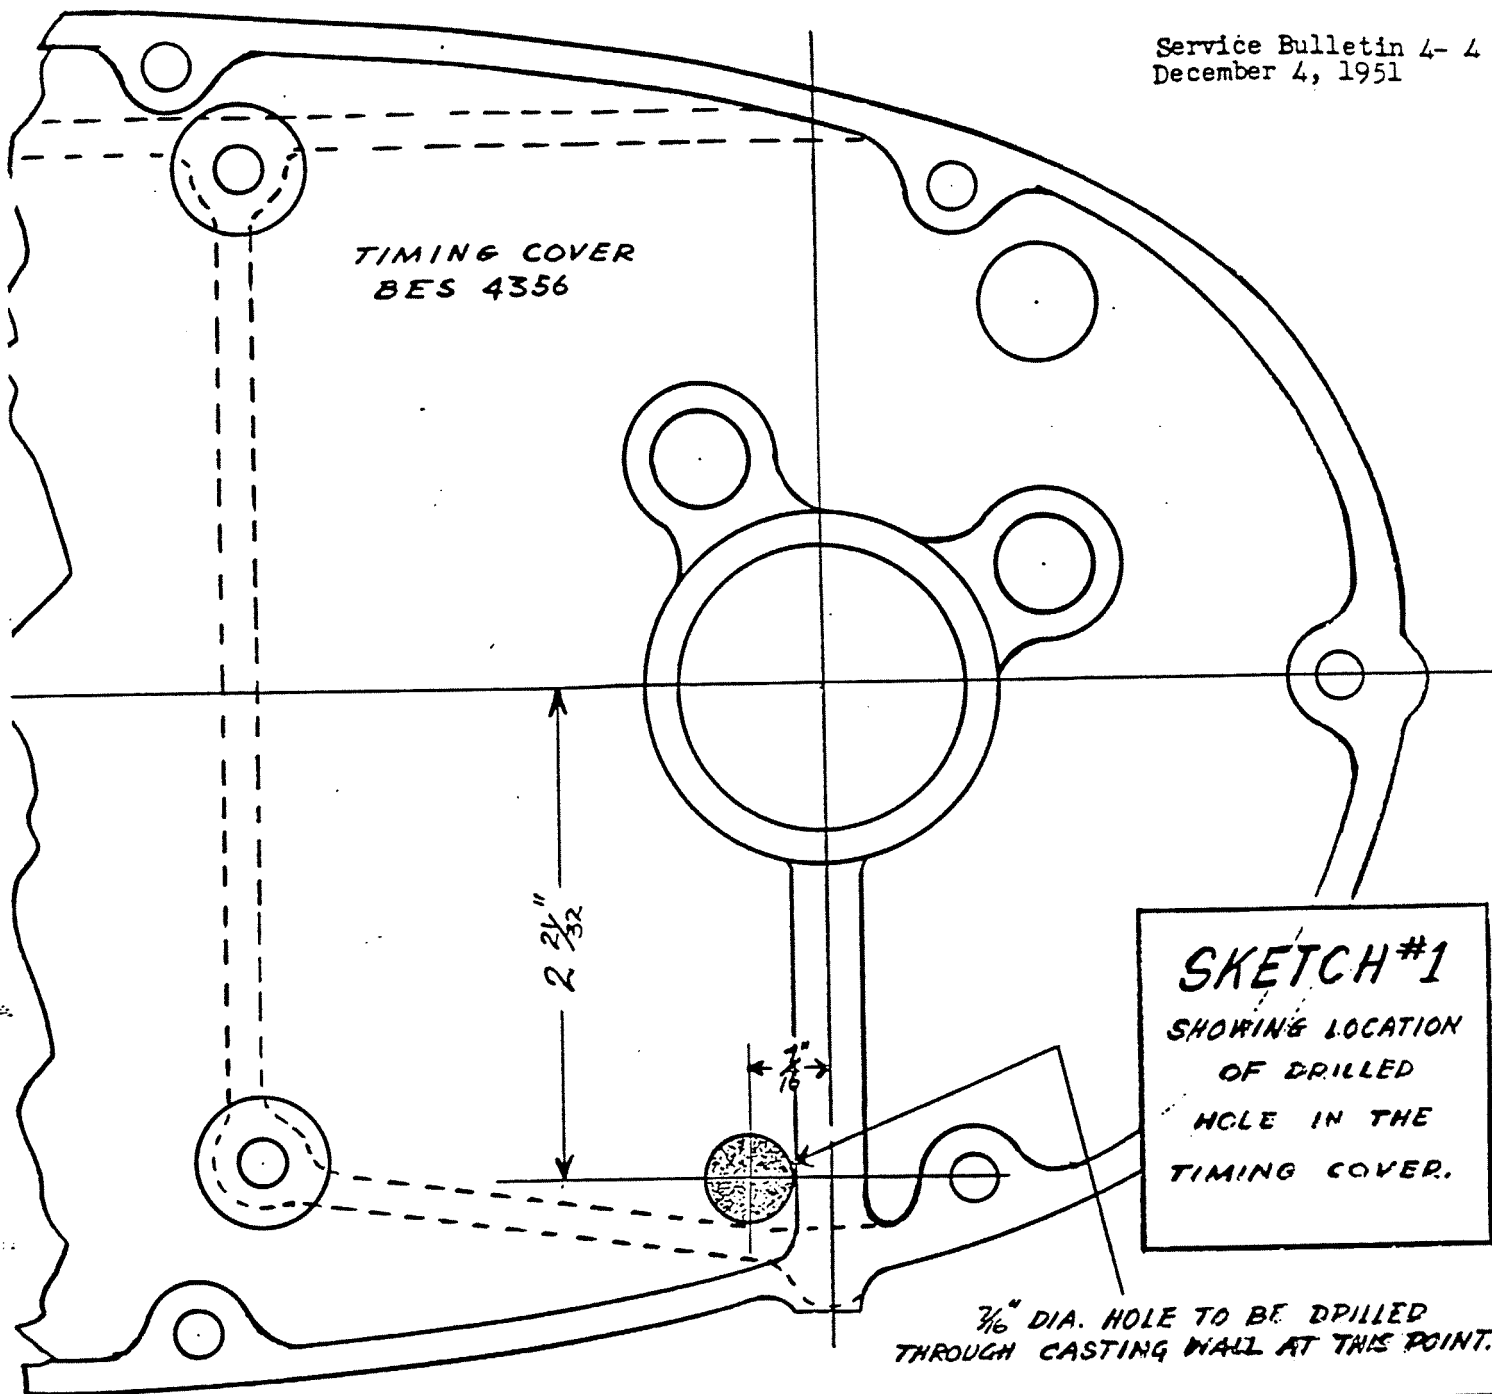
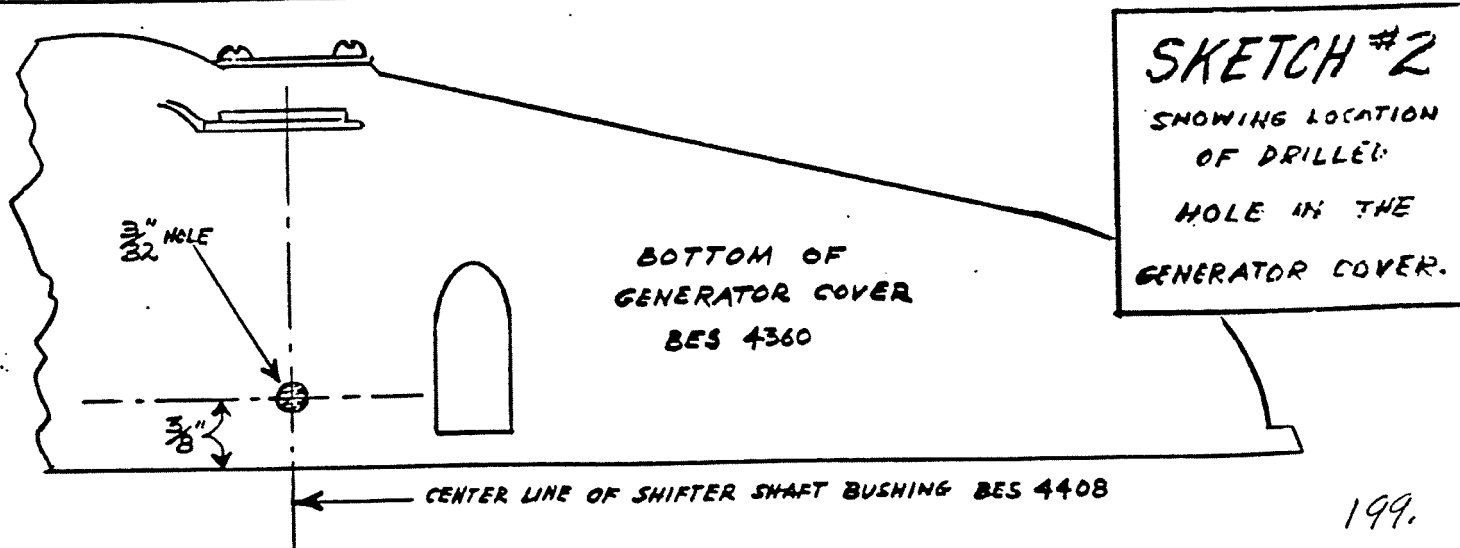
This hole will allow any oil which enters the case to be drained out immediately.

To prevent oil building up in the BES4360 Generator Cover, a drain hole should be drilled in the bottom as shown in Sketch No. 2.
